The Bony Bankart Lesion: How to Measure the Glenoid Bone Loss

Jarosław Skupiński^A, Małgorzata Zofia Piechota^{CDI}, Wojciech Wawrzyniek^A, Jarosław Maczuch^A, Anna Babińska^A

Department of Radiology, District Hospital of Orthopedics and Trauma Surgery, Piekary Śląskie, Poland

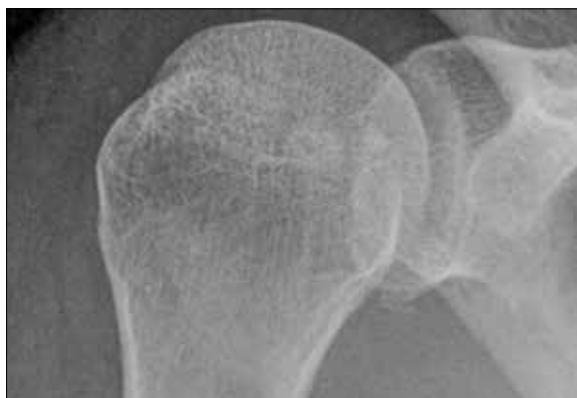
Figure 1. AP radiograph of a stable shoulder presents a preserved sclerotic line.

When diagnosing anterior shoulder instability, the usual initial imaging modality is an anteroposterior radiograph of the shoulder. Radiographs of a stable shoulder present a sclerotic line which represents the normal anterior glenoid rim (Figure 1). The absence of that line for more than 5 mm from the inferior glenoid edge indicates bone lesion of the anterior glenoid rim (Figure 2). That sign is described as LSGL (loss of sclerotic glenoid line) [6]. Jankauskas et al. compared the LSGL sign on true AP radiographs with CT images. It appears that LSGL is moderately sensitive and highly specific for the detection of anterior osseous lesions. Several other projection of radiographs have been used for the imaging of anterior shoulder

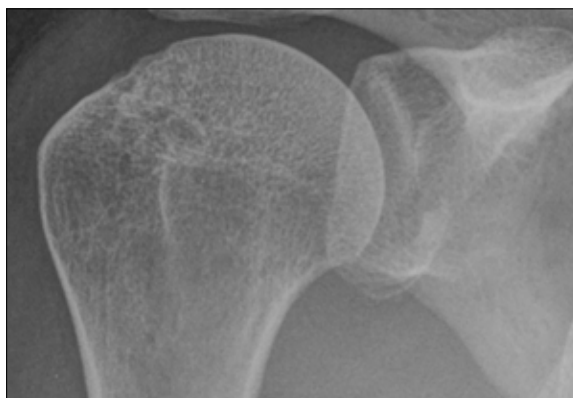
Figure 2. AP radiograph of the shoulder presents the loss of sclerotic line which indicates glenoid anterior rim bone lesion.

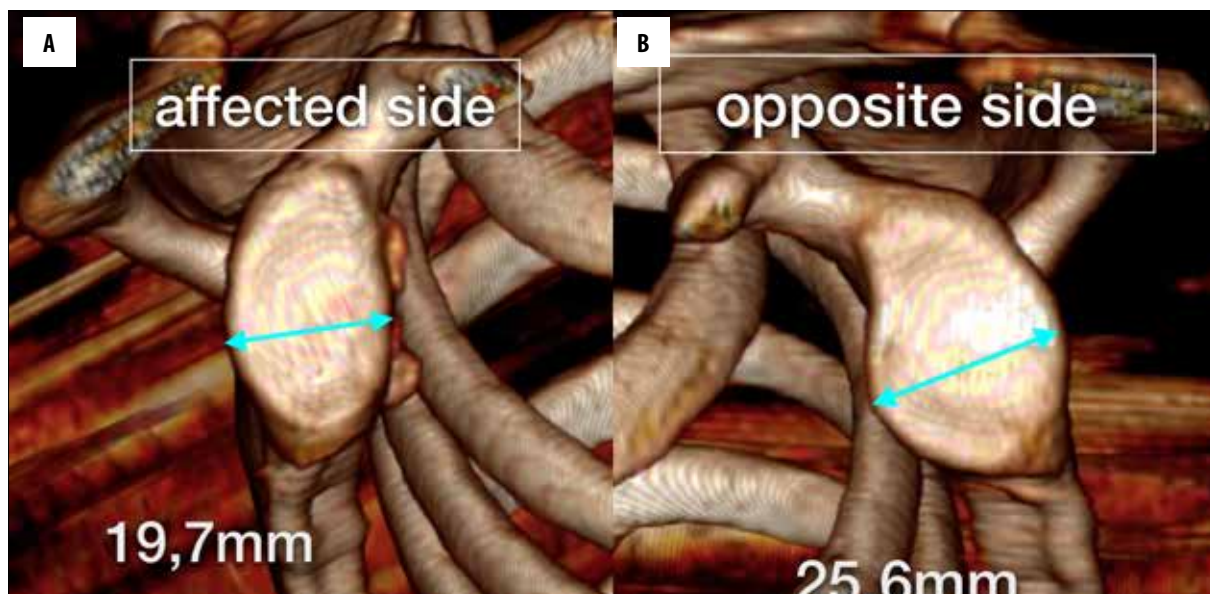
Figure 3. (A) CT 3D reconstruction of the glenoid surface of both shoulders. Affected side: the bone loss in the anterior part of the glenoid is present. (B) Opposite side: the surface of the unaffected glenoid is visualised with unchanged maximum width.

The method introduced by Baudi et al., i.e. the Pico method, is based on CT scanning of both shoulders to provide oblique sagittal images of the healthy and the affected

glenoid surfaces. By drawing two identical circumferential areas on the inferior parts of both glenoids, it is possible to measure the missing part of the circle in the affected glenoid and express that area as the size of the defect. The calculating formula was: $\text{surface D} / \text{surface A} \times 100$, where surface D refers to the size of the missing part of the circle in the affected glenoid and surface A refers to the size of the circle in the healthy glenoid (both areas measured in square millimetres). Intra- and inter-observer readability in the Pico method has been found to be very good [2,10].

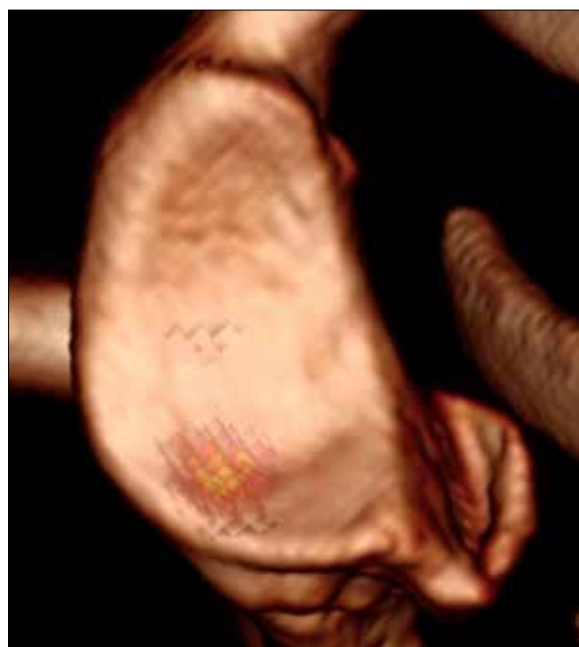
Figure 4. CT 3D reconstruction of the glenoid surface on sagittal en-face view. The bone loss of the anterior part of glenoid is present with a large bone fragment.

A typical feature seen in reformatted en face images of the glenoid fossa is a flattening of the anterior counter. Griffith et al. claim that en face images are more useful in quantifying anterior bone loss than 3D reconstructions, because good-quality 3D reconstructions are not as easily achievable as en face glenoid views [8]. In the same study, the authors proposed the two following measuring techniques as the best indicators of glenoid bone loss. The first is the difference between the maximum width of the glenoid fossa in both the unstable and the contralateral healthy shoulder (Figure 3). The second technique measures the maximum glenoid width and length, which allows to calculate a width to length ratio. Flattening of the anterior curvature with an unchanged glenoid length results in decreased values of this ratio. The referential value for stable shoulders equals approximately 0,7 [8].

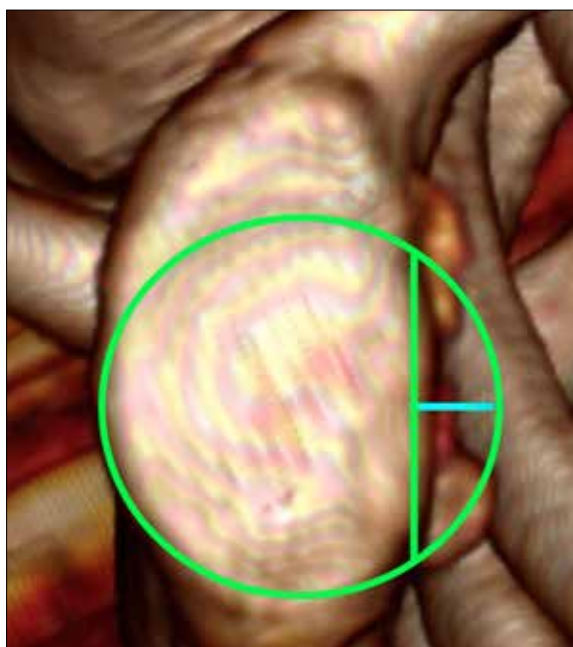
Figure 5. CT 3D reconstruction of the glenoid surface. Best fit circle method. Blue line presents the width of the missing bone fragment.

The principle of measuring bone defects on sagittal en-face views is based on the fact that the inferior aspect of the glenoid resembles a circle. The circle can be drawn along the posterior, anterior and inferior margins of the glenoid [9]. The best-fit circle method led to several different measuring techniques.

3D-CT reconstructions with the humeral head removed have been introduced by Sugaya et al. as another radiological modality to visualise glenoid fossa morphology and to measure bone defect size. In the inferior part of the glenoid, the authors drew a circle which fit the outer counter of the rim. If a bone fragment was present, the authors quantified its size by calculating the ratio between the fragment area and assumed an area of the lower circular portion of the glenoid (Figure 4). In case there is no free osseous fragment, the missing part of the circle resembles the defect (Figure 5) [11]. The main differences between 3D (Sugaya) and 2D (Pico) techniques is that the 2D (Pico) reconstructions require both shoulders to be scanned. According to Griffith et al., the crucial criteria for the analysis of glenoid fossa on CT images require comparisons with the healthy contralateral side, which makes the 2D-CT reconstructions useful for only unilateral glenoid rim lesions [12].

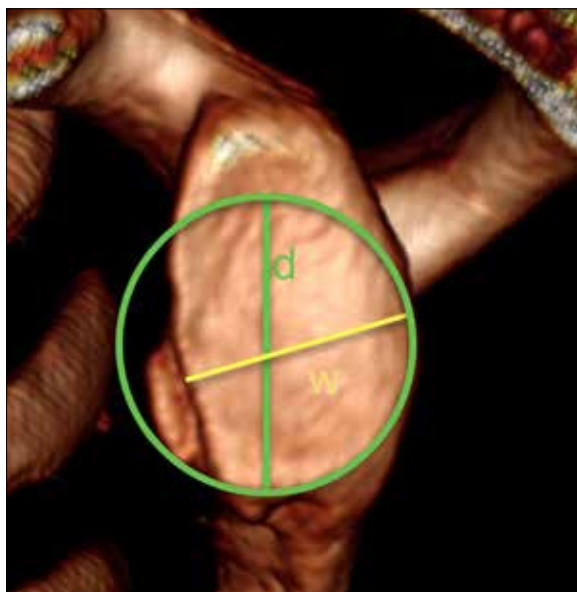
Figure 6. CT reconstruction of the glenoid surface. Best fit circle method with the use of Chuang measuring technique where „d” is the width of the unaffected glenoid and „w” represents the width of the injured glenoid.

Another technique using 3D CT reconstructions is the glenoid index described by Chuang et al. The glenoid index is the ratio between the width of the injured glenoid and the width of the unaffected glenoid before an injury (Figure 6) [13]. This technique is similar to the Pico technique, where the shoulder before an injury is tantamount to the contralateral healthy shoulder described by Baudi. Finally, a unilateral quantification of the unstable shoulder in 3D CT images was used in Barchilon et al. study. These authors proposed a simple method of measuring the size of the glenoid defect by calculating the ratio between the depth and the radius of the best-fitted circle. The depth was defined as the line drawn from the centre of the circle to the injured anterior glenoid margin [14].

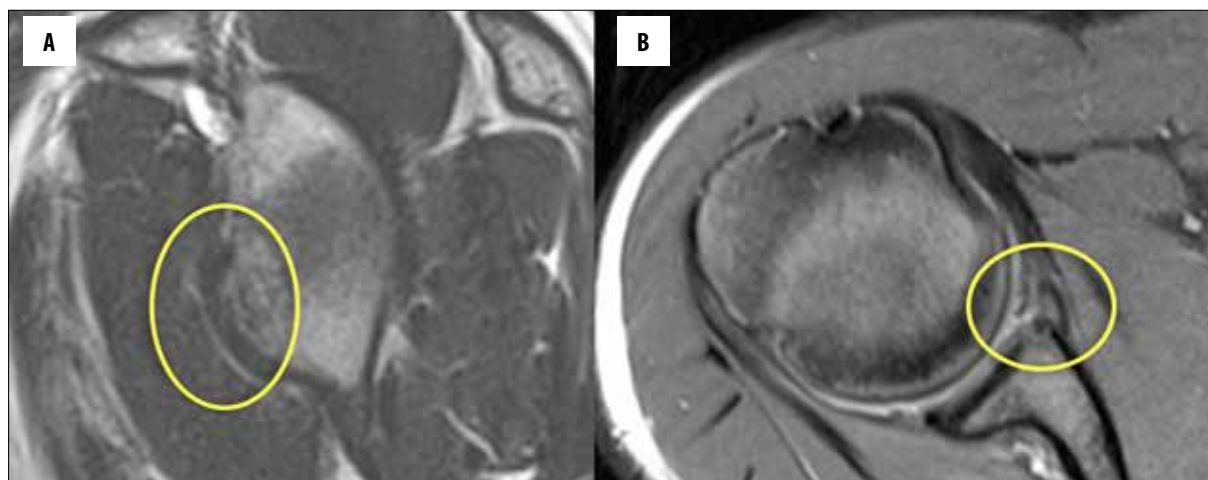
Figure 7. Sagittal and axial T2 images of the shoulder. The bony Bankart lesion is visible.

Recently, new studies have investigated the use of 3D MR reconstructions to evaluate glenoid bone loss. The possibility of using 3D MR reconstruction instead of 3D CT may benefit the patients with soft Bankart who are suspected for extra glenoid bone loss, by sparing them the cost, time and radiation dose of an extra CT examination. So far, MR has been the gold standard for imaging soft tissue lesions but in several clinical studies it has also appeared to be an accurate modality for measuring glenoid bone loss [17–19]. The best-fit circle method is exactly the same when using CT or MR reconstructions (Figure 7). Gyftopoulos et al.,

after applying a circle in the inferior part of the glenoid, drew a line through the centre of the circle, which represents the maximum width of the glenoid. The line between the anterior margin of the circle and the anterior margin of an injured glenoid represents the size of the osseous loss. The size of the bone defect divided by the glenoid width and multiplied by 100 represents the percentage of glenoid bone loss [17]. 3D MR reconstructions are produced using water-based images from the Dixon sequence. Producing 3D MR osseous models of glenoid fossa takes comparable time to producing 3D CT reconstructions, and in addition, it spares the patient another radiation dose [17]. Because of radiation reasons, MR is favourable especially in young patients or when scanning both shoulders. In a recent publication, Owens et al. described a formula to estimate the expected width of the glenoid with a known height, which allows to calculate the amount of bone defect [20]. A significant disadvantage of this study was that the exact width of the bone loss does not precisely correspond to that estimated by the formula.
